Manhole Inspection Summary

Manhole # **S19G__025MH**

Insp Date: **10/1/07 8:23 AM**

Location Address: **30 PULASKI ST**

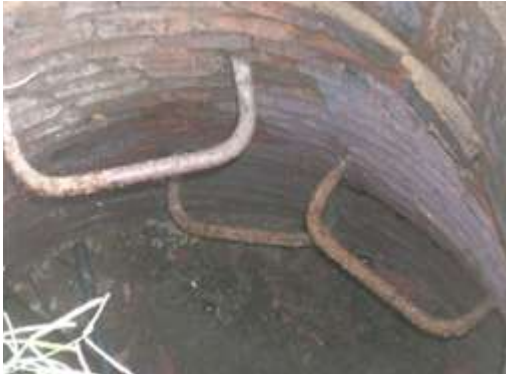
Defect 1

Count: **3** Missing: **0** ☒ **Corroded**

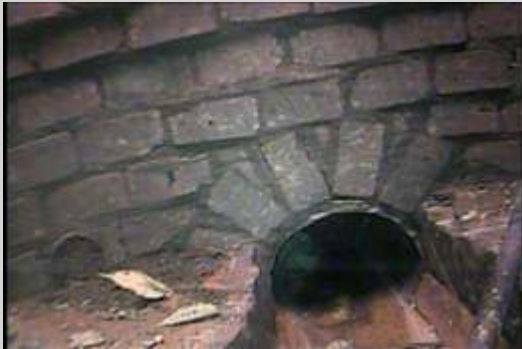
12 O'Clock Outflow

8 in. Circular Gravity Sewer
Pipe Out @ 12 O'Clock

Pipe Height: **8.4** (in.) Rod and Bar (Angled)
Pipe Material: **Clay** ☐ Pipe Lined
Invert Depth: **6.51** (ft.) Flow Characteristics: **Slow**
Deposits: ☒ None ☐ Mud ☐ Sludge ☐ Debris ☐ Grease
Silt Depth: (in.) Deposits Extent:
Infiltration: **None** Pipe Seal Cond: **Sound**

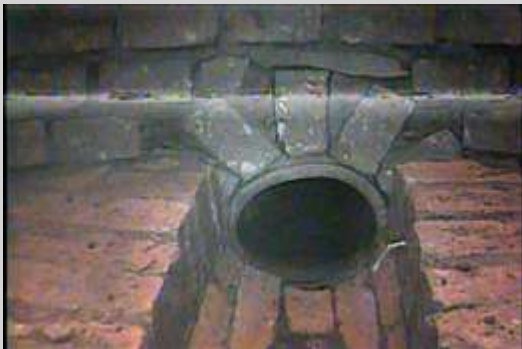
6 O'Clock Inflow

6 in. Circular Gravity Sewer
Pipe In @ 6 O'Clock

CORRODED STEPS

Pipe Height: **6** (in.) Rod and Bar (Angled)
Pipe Material: **Clay** ☐ Pipe Lined
Invert Depth: **6.00** (ft.) Flow Characteristics: **None**
Deposits: ☒ None ☐ Mud ☐ Sludge ☐ Debris ☐ Grease
Silt Depth: (in.) Deposits Extent:
Infiltration: **None** Pipe Seal Cond: **Sound**

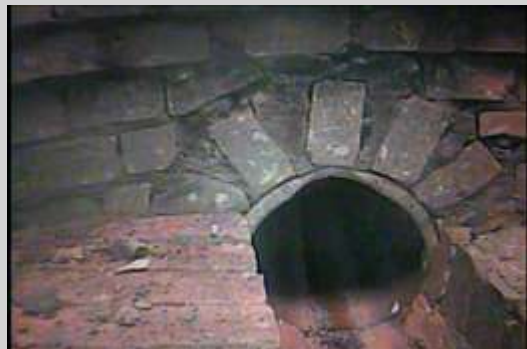
9 O'Clock Inflow

8 in. Circular Gravity Sewer

Pipe In @ 9 O'Clock

CORRODED STEPS
